A SHIPBUILDER'S FIELD TRIP

AN ALL-EXPENSE-PAID *BLAST* ON COMPANY TIME

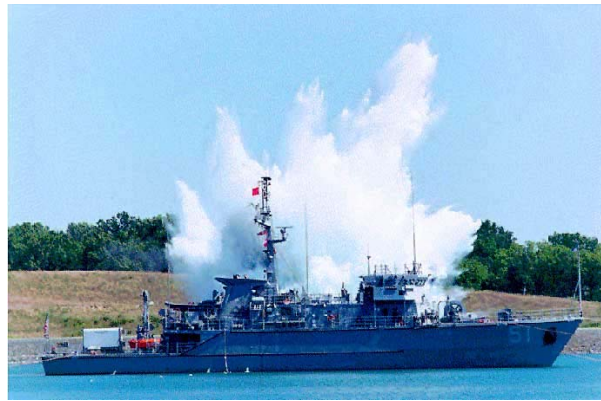
To help educate us about the damage that underwater explosions could cause, members of the NIMITZ design team were shown a navy film made during the shock test experiment involving the minesweeper. The entire sequence of events filmed took place in the vessel's machinery space. A high-speed camera, positioned on a flexible mount, captured grainy scenes of what happened when an underwater explosion was deliberately set off just feet from the vessel's hull.

The resultant shock wave completely wrecked the space. The main engines broke free of their foundations, which distorted and cracked, in places. A large electrical generator came completely free and rolled on its side. Piping systems ruptured and, according to an accompanying report, almost all the electrical breakers opened. Many smaller items also flew around the space, and clouds of dust and dirt rose from their hiding places.

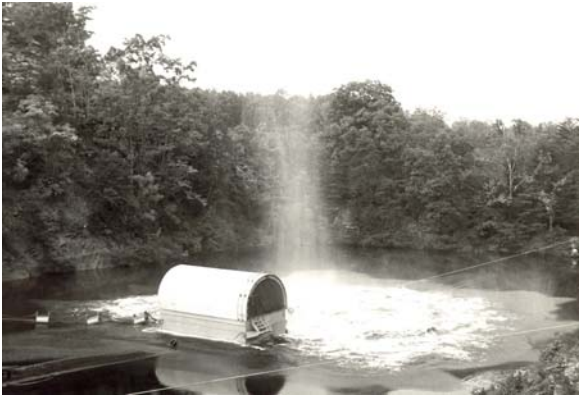
Explosive charges were placed at the prescribed distances and depths from the barge and also positioned on the side or end away from the test center. Each charge was set off remotely, following the traditional 10-9-8-7-6-5-4-3-2-1-FIRE! count-down as everybody present tensed up. In spite of that sequential warning we all jumped, anyway, when each muffled blast threw a plume of water high in the air and rattled the test center building. Small waves soon lapped the edges of the quarry as the plume of water subsided.
